Volvo Trucks

Recall Alerts

Bulletin: SRA-V20-06
Date: December 17, 2020
Valid to: N/A
Action Required? Yes No

From: Gerard Hones, Regulatory Specialist Government Reporting
Subject: Safety Recall RVXX2006, Norgren Collet Inspection/Replacement

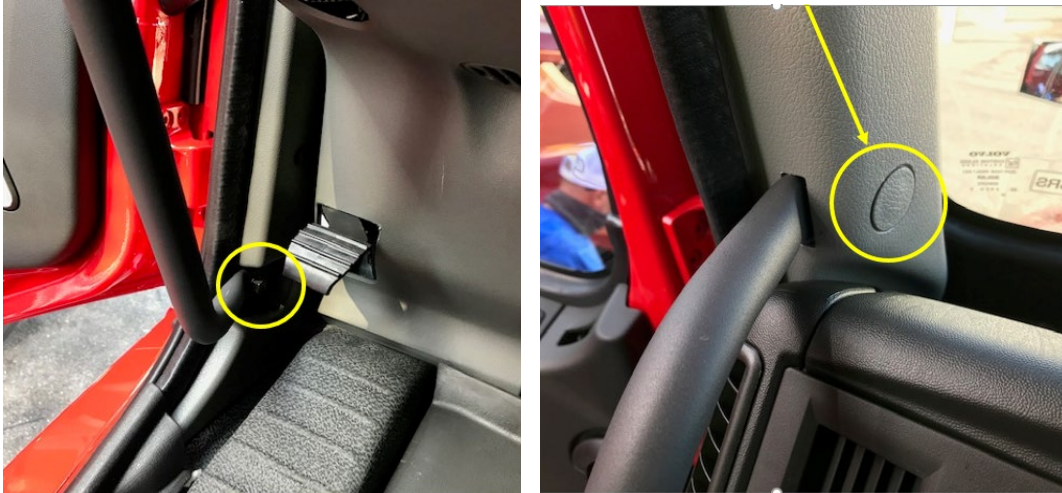
1. Remove grab handle fasteners. Plastic cap will have to be removed to access top grab handle fastener. Remove grab handle.

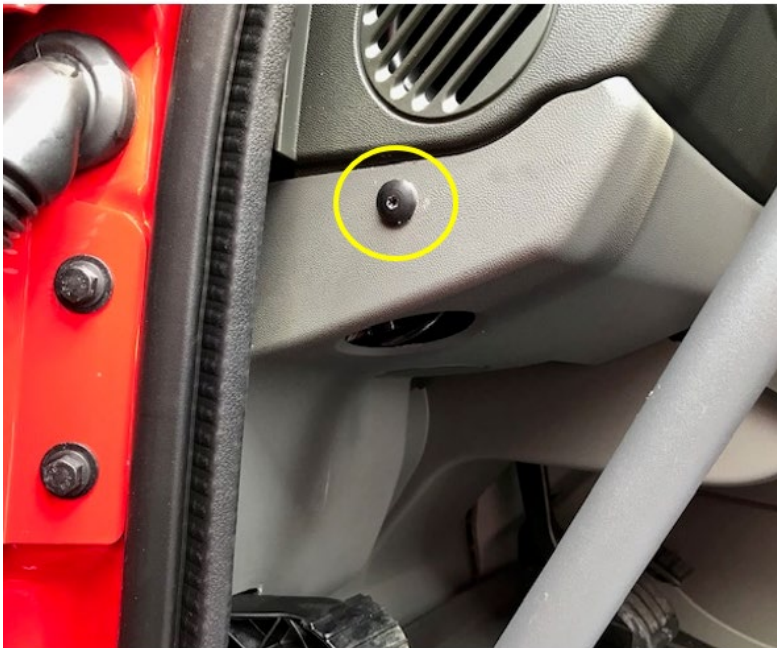
2. Remove fastener holding panel in place

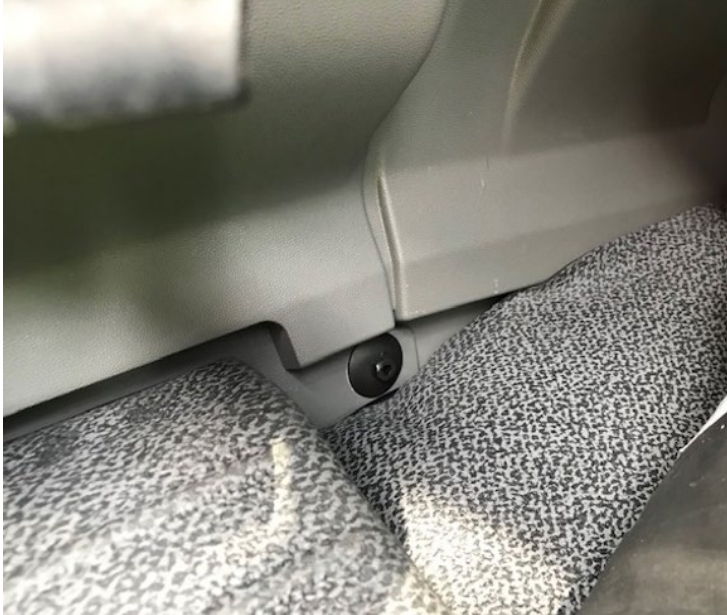
3. Pull floor mat back to expose fastener. Remove fastener. Remove panel exposing interior side of pass through.

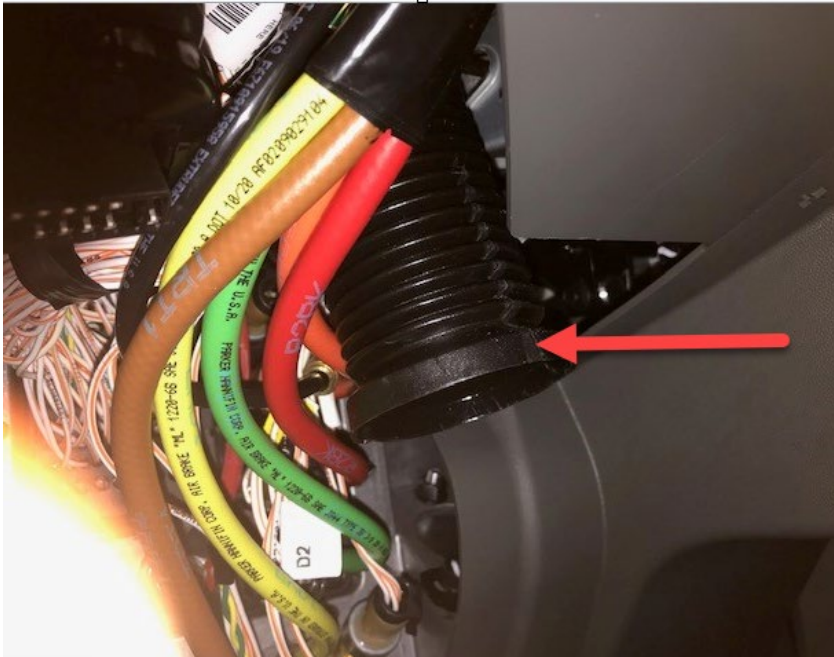
4. Pull down on air vent, moving it out of the way to allow for air hose inspection.

5. On each air hose at the pass through connection, one at a time, push in twice, and then pull out firmly.

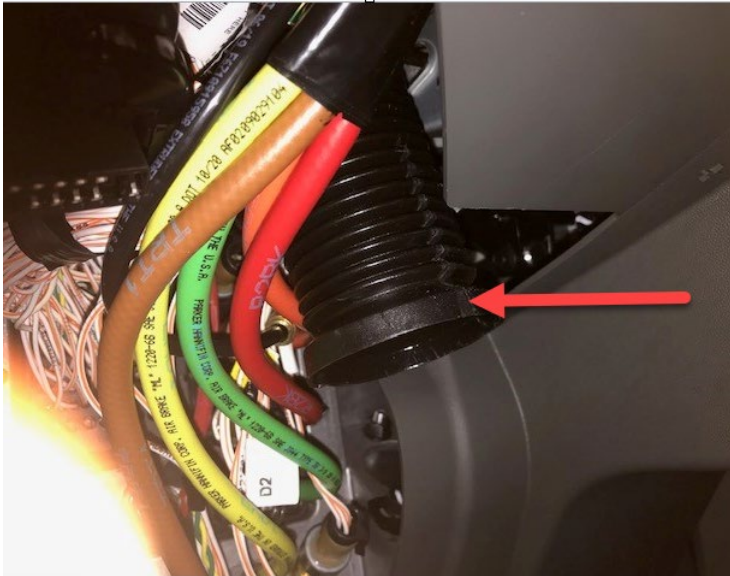
6. If no fault found, inspection is complete. If any hose comes free or is loose, proceed with replacement of affected collet(s) on page 9.
7. Reinstall air vent.

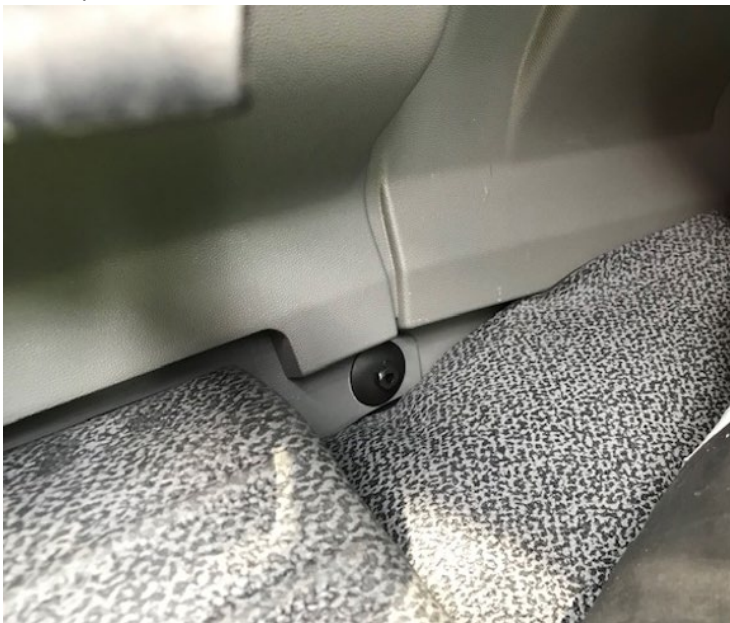
8. Install panel and fastener.

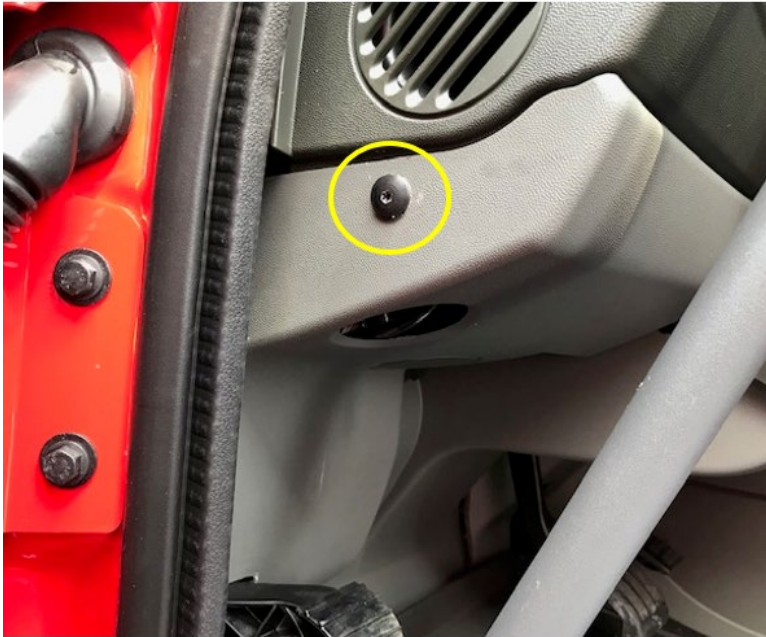
9. Install fastener

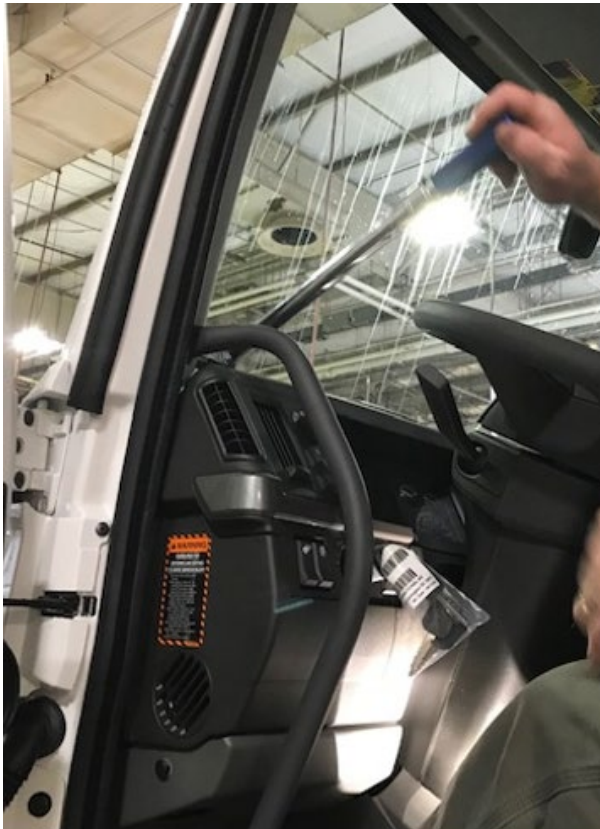
10. Install grab handle, torque fasteners to 18 +/- 3 foot pounds.

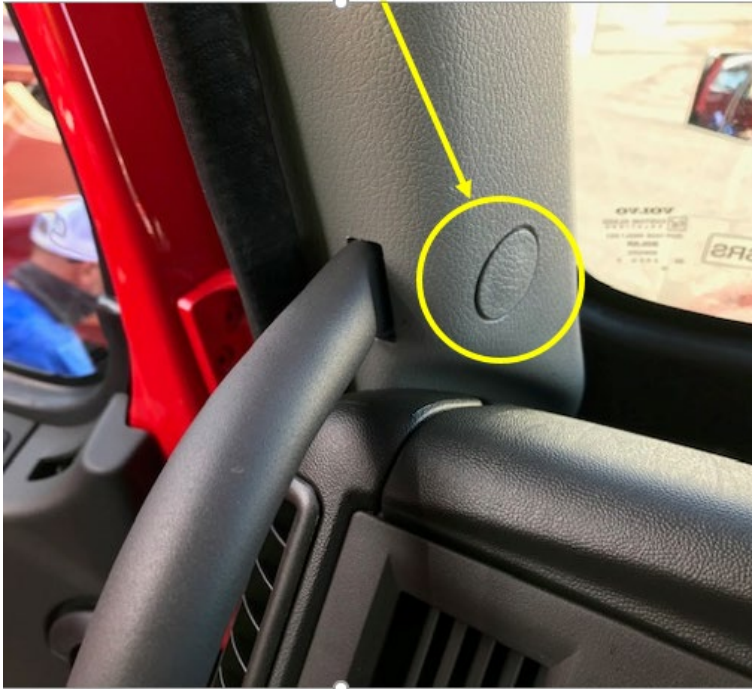
11. Install plug.

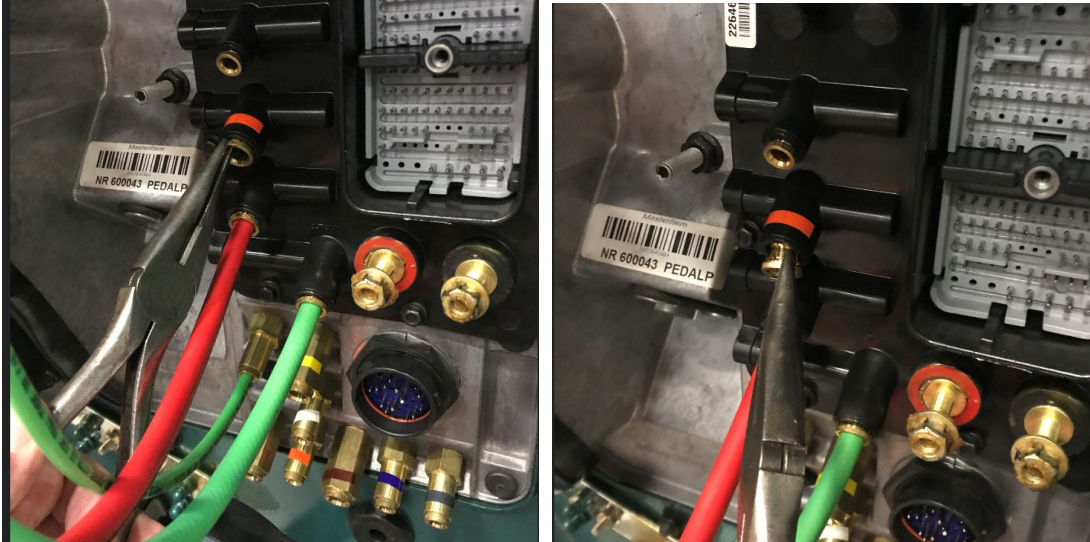
1. Remove collet from port in pass through using a pair of pliers.

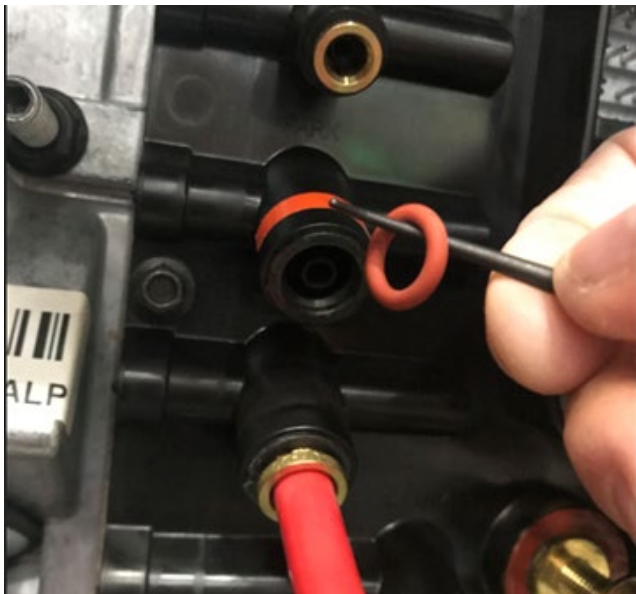
2. Remove the o-ring from the port, and discard.

NOTE: New O-ring is required.

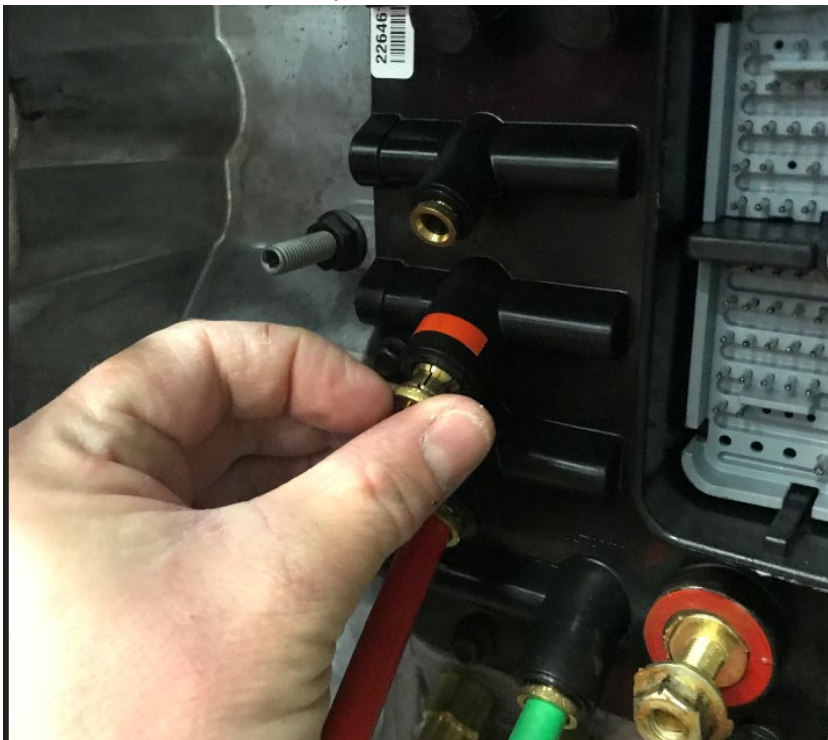
4. Install the new collet in the port.

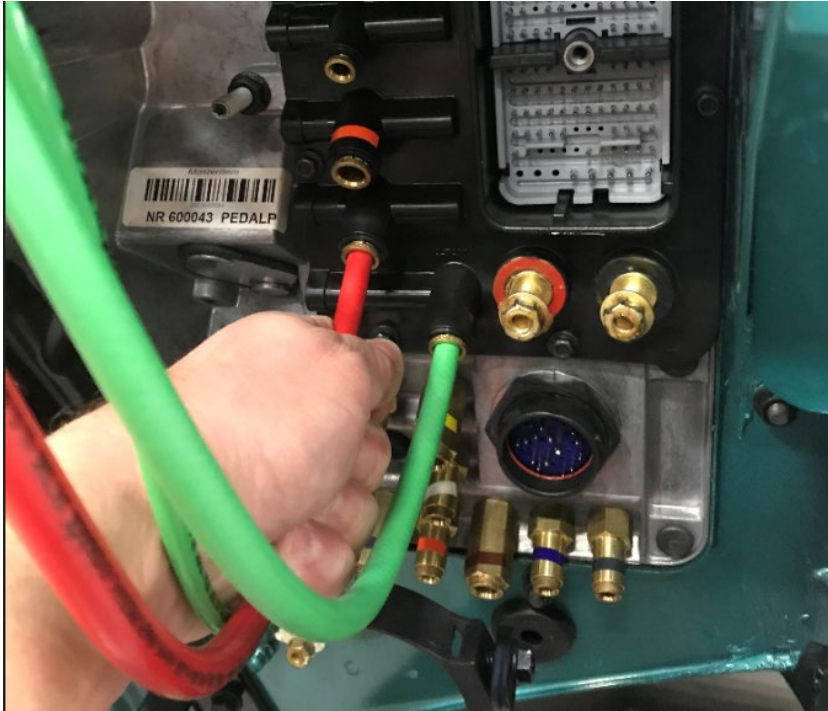
5. Insert the airline into the port, repeat two firm pushes and one pull on affected airline/collet to ensure the collet has been repaired.

6. Repair complete, repeat on all loose or free air hoses.
