# SAFETY RECALL

Volvo Trucks North America

Release Date	Number	Release	Page
02.2024	RVXX2316	01	1(5)

## Sheppard Steering Gear VN

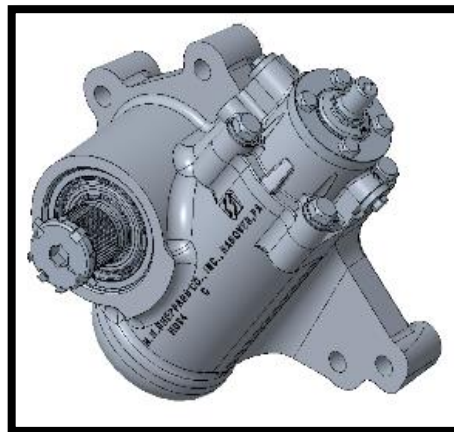
1. Secure vehicle for service.
2. Place the transmission in park or neutral.
3. Install wheel chocks.
4. Unlatch and raise the hood.
5. Locate the Sheppard steering gear serial number following the instructions below.

It is not necessary to remove the steering gear box to locate the serial number.

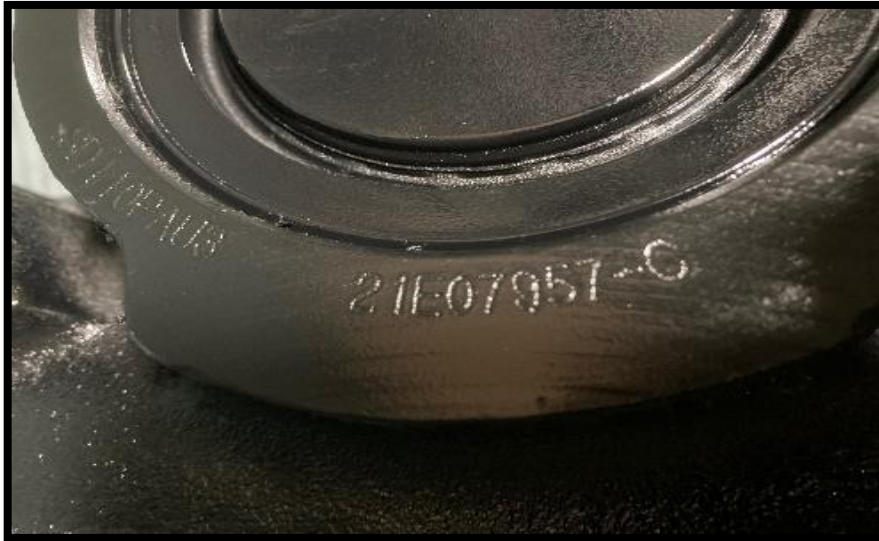
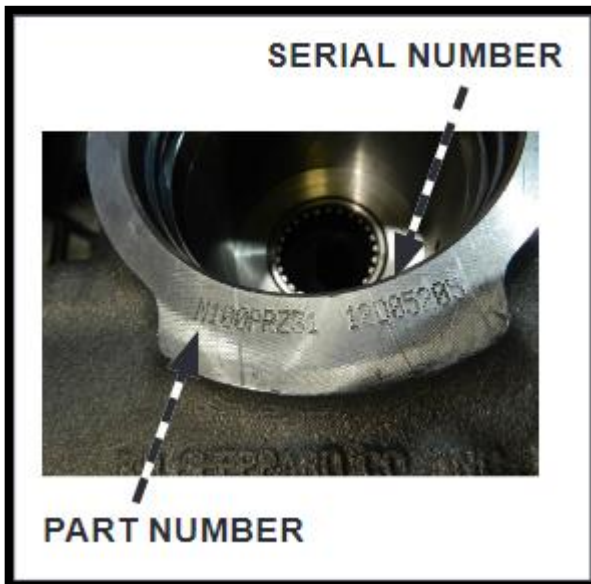
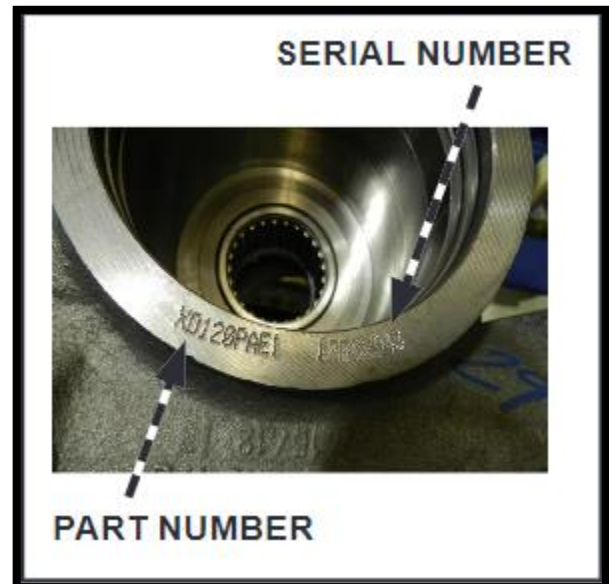
6. Some configurations the serial number is between the steering gear and the frame. It may be

necessary to turn the wheels, so the pitman arm moves out of the way.

If the serial number or part number cannot be easily read due to paint application, gently scrape the number(s) with a flathead screwdriver, wire brush, or emery cloth, or apply acetone. Too much intervention may cause the numbers and letters to be illegible.

7. Compare the serial number on the steering gear to the serial numbers listed in the chart below.

- **If the serial number is not listed in the chart below:** the vehicle can be returned to service with no further remedy action required. Complete all paperwork and return to service.
- **If the serial number is listed in the chart below:** the vehicle will require removal and replacement of the steering gear. The Sheppard steering gear serial number and Impact part number will be required for parts ordering.
